JOBSITE INSPECTION FORM

Parker Safety Group LLC

Project Location: 154 Pearl St, Chelsea

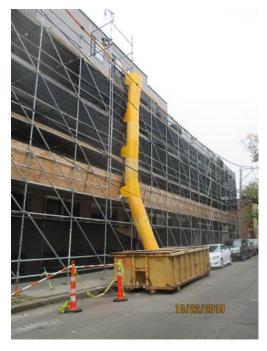
Closed Chute

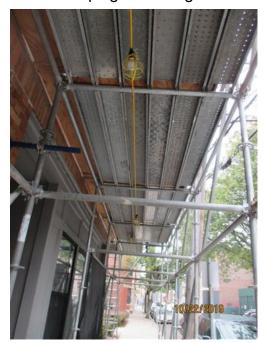
Temp lights all caged

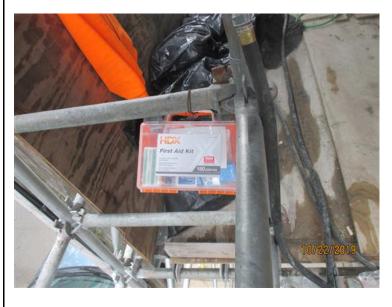
First aid kits in multiple locations

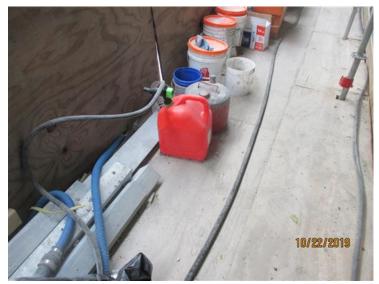
Work Boots being donned?]
	Respirators cleaning supplies provided?]
15 Minute Continuos Eye Wash On Site?]
]
SUBPART F - FIRE PROTECTION				Improper gas cans on platform
Correct size	and category fire extinguisher provided?	/		
1 extinguisher at each stairway?		\		1
Fire extinguisher located within 100' of work area?		/		
F	ire extinguishers within expiration date?	/]
Workers trained in NFPA Hot Work?				1
Flammables stored near heat sources?				1
Flammables stores near ignition sources?				1
Material Storage areas ventilated if needed?				1
	Oily rags stored properly?			1
				1
				┫

Improper Gas Can

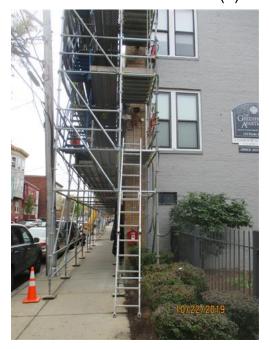
INSPECTION CATEGORY YES NO COMMENTS SUBPART G - SIGNS AND BARRICADES Access ladder left without any signage -- easy access to anyone who Job site Control signs in place? was willing to use ladder Regulartory signs in place? Barriers in place to control access? SUBPART H - MATERIAL HANDLING Demo Chute in order Material stored 6' away from floor openings/hoistways? Work areas keep clear from debris and material? Any rigging equipment inspected before use? Any hoisting of materials performed by trained worker? Materials dropped more than 20' in a closed chute? Material drop zones barricaded 6' from drop area? SUBPART I - HAND AND POWER TOOLS Worm drive saw - no guard -- REMOVE FROM SITE All guards in place? Double insulated or three prong grounded? Powdered Impact tools properly trained for? Tools in good working condition? Ventilation for any gas powered tool/equipment? SUBPART J - WELDING AND CUTTING N/A Gas cylinders and tanks upright and secured? Empty cylinders and tanks seperated from full tanks? Caps secured on cylinders and tanks? Equipment inspected by qualified person prior to use? Fire extinguishers close to work area? Ventilation provided during operation? Hot Work Permit in place if required? SUBPART K - ELECTRICAL Did not see any GFCI in use All cords plugged into exterior rated GFCI? Are extension cords heavy duty rated? Temp lights had all cages in order Are main cord runs to be minimum 12/3 gauge? Any cords less than 14/3 guage/heavy duty rating? Cords protected from damage if run through openings? Temporary lights provided with bulb protection? Tools disconnected for cleaning or changing blades? Battery chargers protected from damage? Generators grounded/bonded? SUBPART L - SCAFFOLDS All electrical lines were protected by utility company Scaffold inspected by competent person before work? Proper clearance from electrical sources? Erected/moved/dismantled by competent person? Weight Capacity on platforms observed?

Access Ladder violations (2)

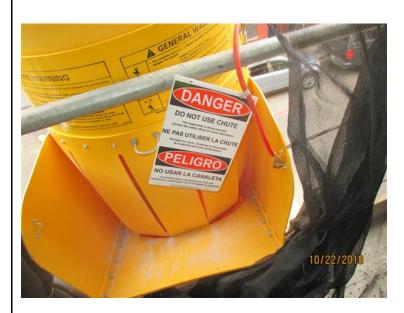
Chute with instructions

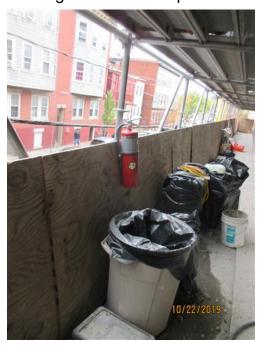
fire extinguishers at mulitple locations

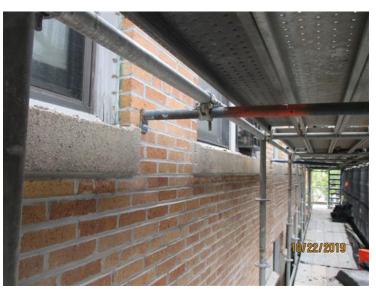
scaffold secured

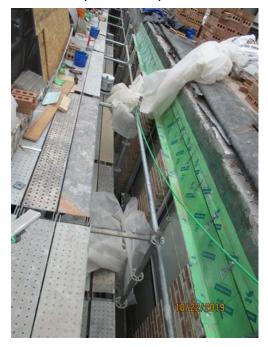
platform open

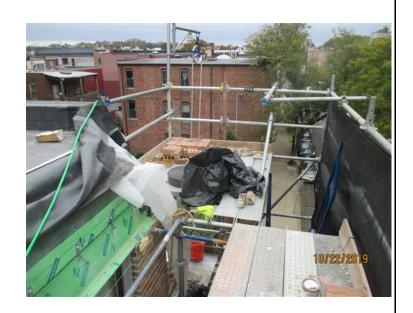
Hoisting area with open platform

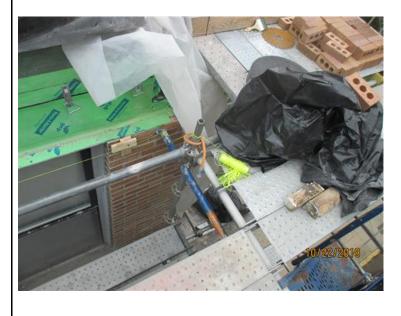
Hoisting area (2)

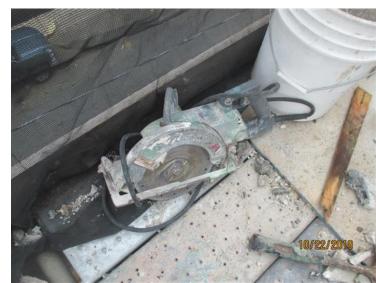
unguarded saw

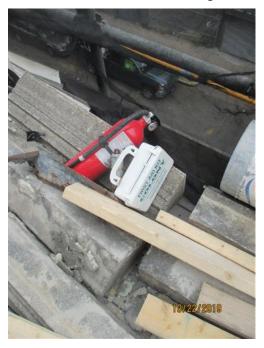
first aid kit and fire ext among debris

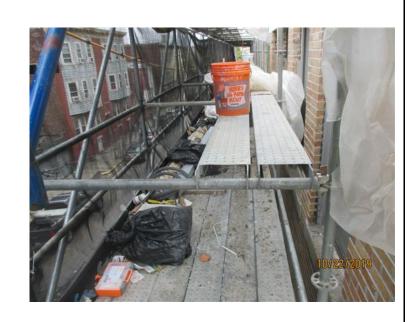
debris area
